Part 2 of Attachment J to the Allocation Recommendation Report (ARR0772-ARR1178)

Diamond Alkali OU2 Allocation

ADR Confidential
Facility Data Report**CONOPCO, Inc.****(as successor to Corn Productions Corporation (CPC) / Bestfoods, former parent of the Penick Corporation)**

Facility Name, Address and Size: Conopco d/b/a Unilever (as successor to CPC/ Bestfoods, former parent of Penick Corporation), 540 New York Avenue, Lyndhurst, New Jersey. The site is located on 14 different Lot numbers that fall within Block Numbers: 2A, 3, 73, 79 and 83 (PAS-00112914); 17-acre site (PAP-00048761). The site is also referred to as 550 New York Avenue, Lyndhurst (PAS-00112742; PAS-00112829).

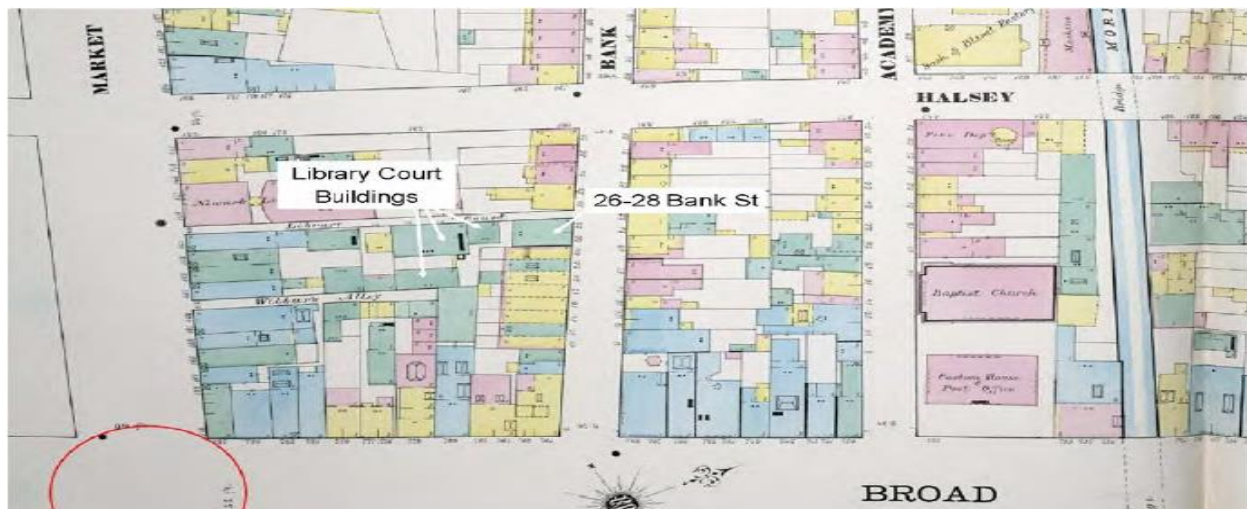
(PAP-00480547; PAP-00728761 as modified by Expert Report)

Note: The dark vertical line in the larger of the Library Court buildings indicates the location of the boiler (PAP-00728761).

The 26 Bank Street (store and residence) and Library Court (factory) (1869 – 1887) occupied 7,900 square feet (0.18 acres), based on scaling an 1874 fire insurance map (PAP-00480547; PAP-00728759). There is no evidence of any production activities at 26 Bank Street (PAP-00728765). The plant behind 26 Bank St. consists of three brick buildings, one three stories high, with a basement, covering an area of 40x60 feet; one 25, 50 feet, also three stories high and a two-story building, 25x25 feet (PAP-00480559).

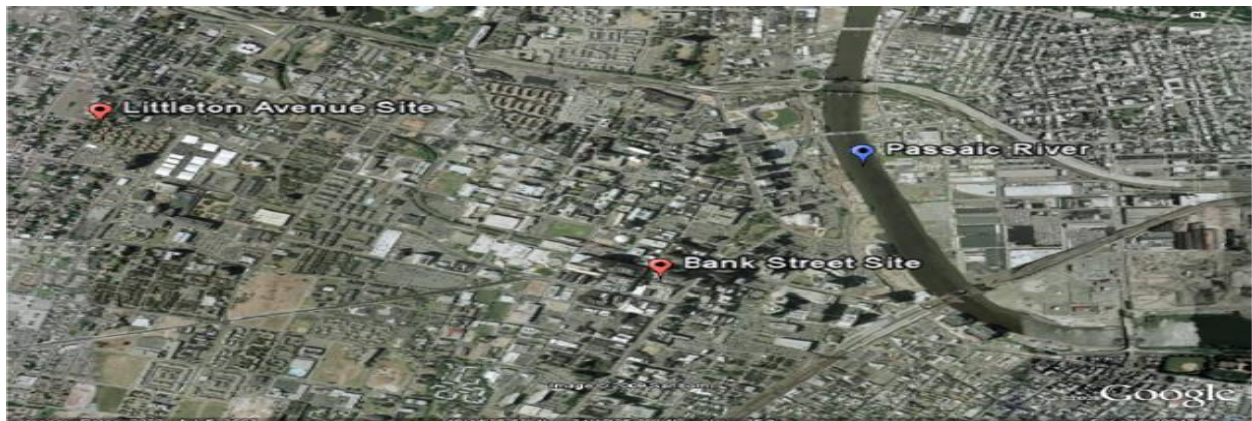
The following image from the 2009 DEF shows the location of the Bank Street site in relation to the Passaic River (PAS-00027478).

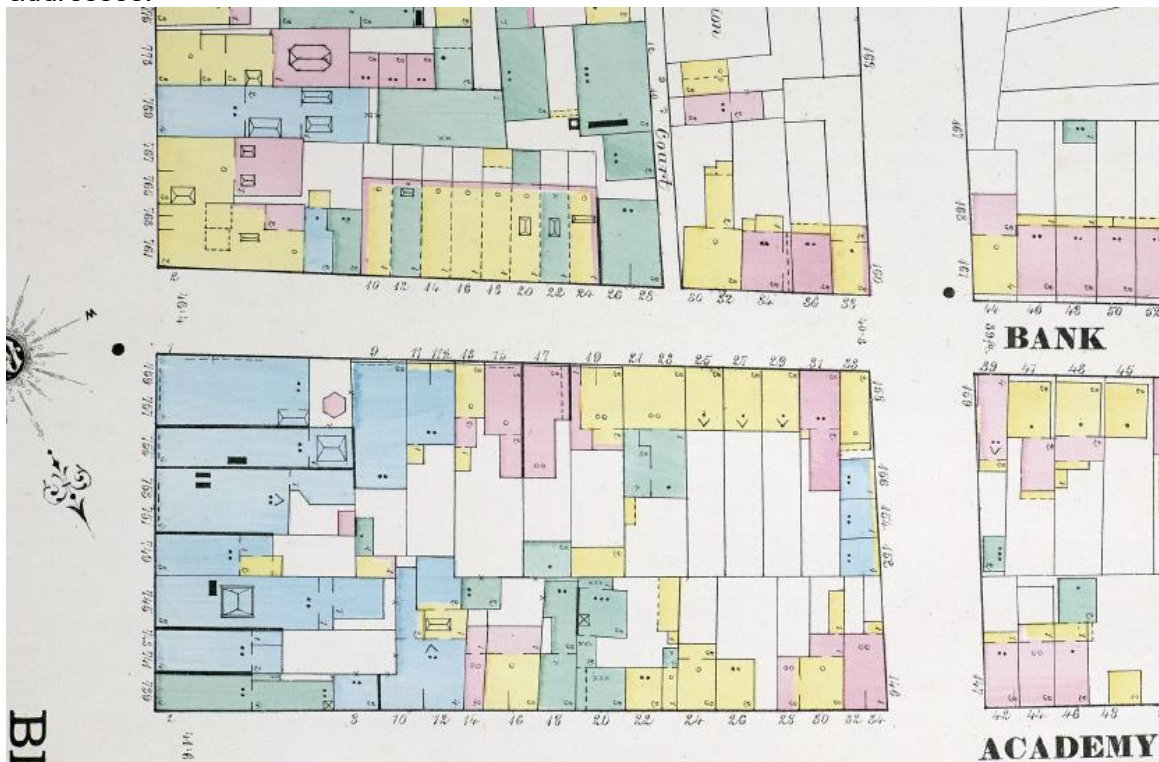
1892 Sanborn Map of 7, 13, and 26 Bank Street (PAP-00332555)

The following Sanborn maps from 1874 and 1892 show the location the Bank Street addresses:

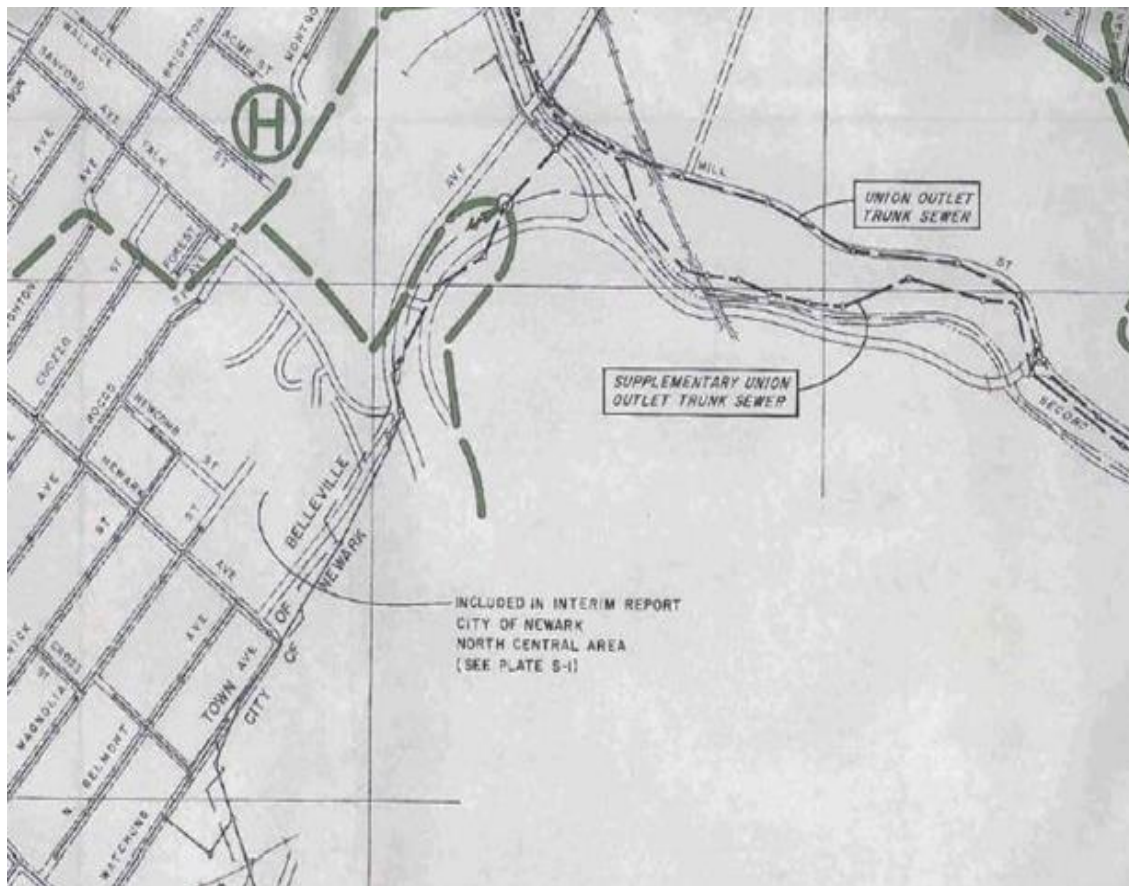
(PAS-00028203)

The Primary Battery Facility was located within the Second River Union Outlet Overflow District. According to the *Report upon Overflow Analysis to Passaic Valley Sewerage Commissioners* for the Second River Union Outlet, prepared by Elson T. Killam Associates, Inc. in 1976, "under normal dry weather flow conditions, the flow is diverted to the PVSC interceptor via the regulator. During periods of rainfall, none of the sanitary flow enters the interceptor. The entire flow is discharged through the outfall line into the Passaic River" (PAS-00028167). The report noted that the District covered 10,227 acres (PAS-00028170).

Based on a PVSC Sewer System Evaluation Survey, dated July 1979, the site was located within the Second River Union Outlet Overflow District (PAS-00028203).

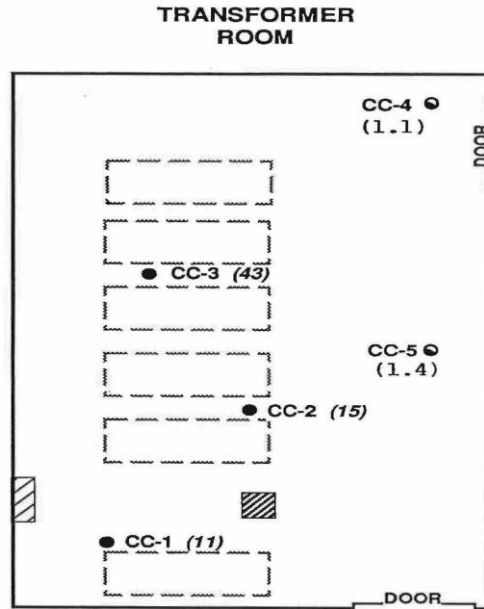
(PAP-00332171)

The following figure from the January 15, 1992 *Cooper-Wiss Facility Quarterly Progress Report*, shows the PCB sampling locations with detected concentrations in parentheses:

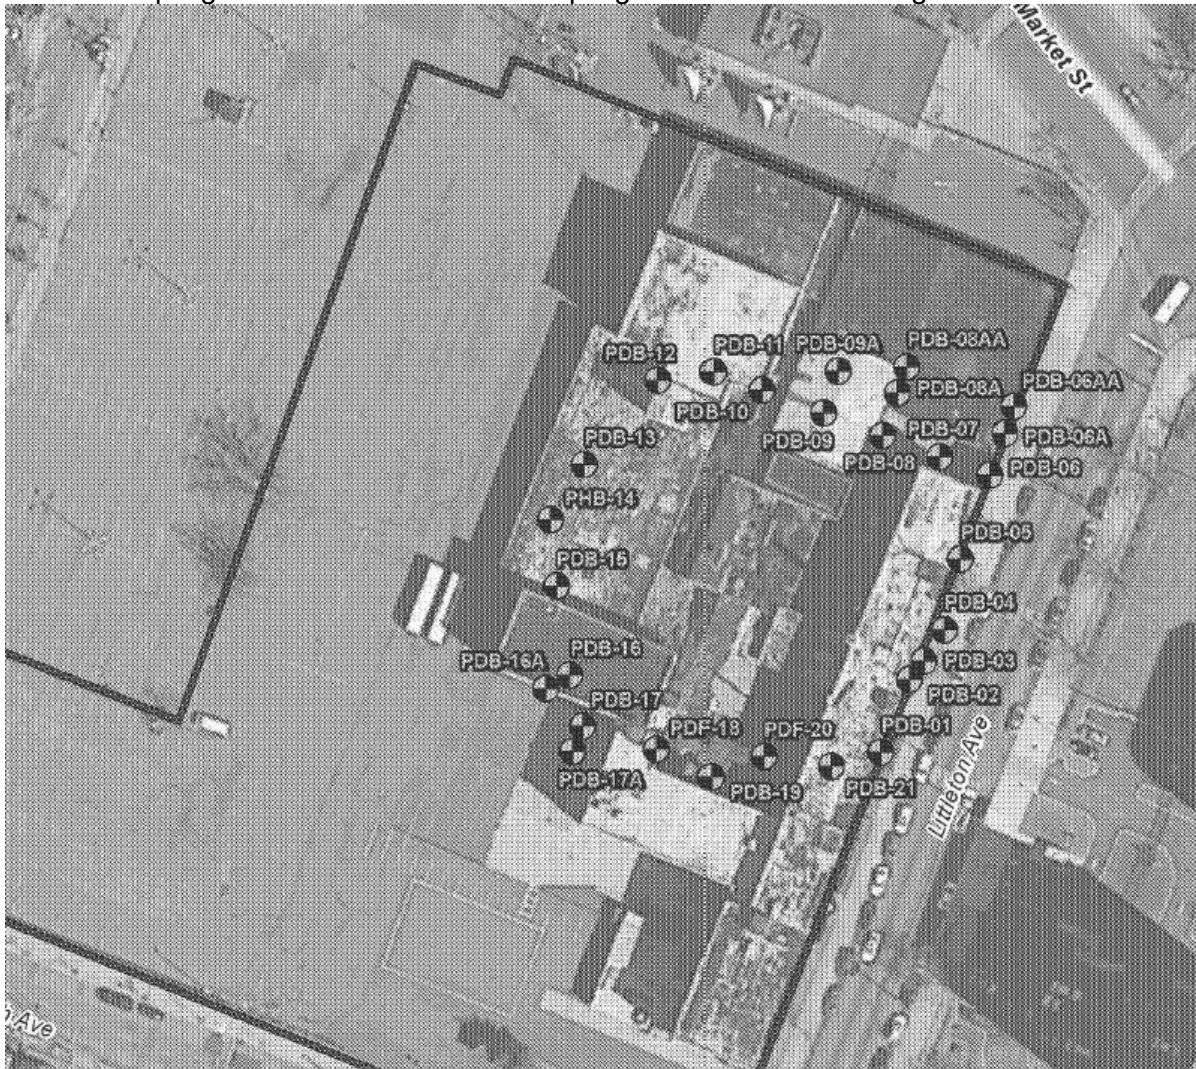
(PAP-00332476)

The sampling locations for the 2014 sampling are shown on the diagram below:

respectively, exceeding the NJDEP Residential Direct Contact Soil Remediation Standard of 6 mg/kg. PDB-09B also exceeded the Non-Residential Direct Contact Soil Remediation Standard of 17 mg/kg and the Impact to Groundwater Soil Screening Level of 25 mg/kg. The remainder of the naphthalene concentrations ranged from Not Detected (ND) to 5.98 mg/kg (PAP-00332474-75). [Note: Although this sampling occurred after the timeframe that Cooper Industries operated the 33 Littleton Avenue site, this information is included here to document the effects of petroleum released at the facility.]

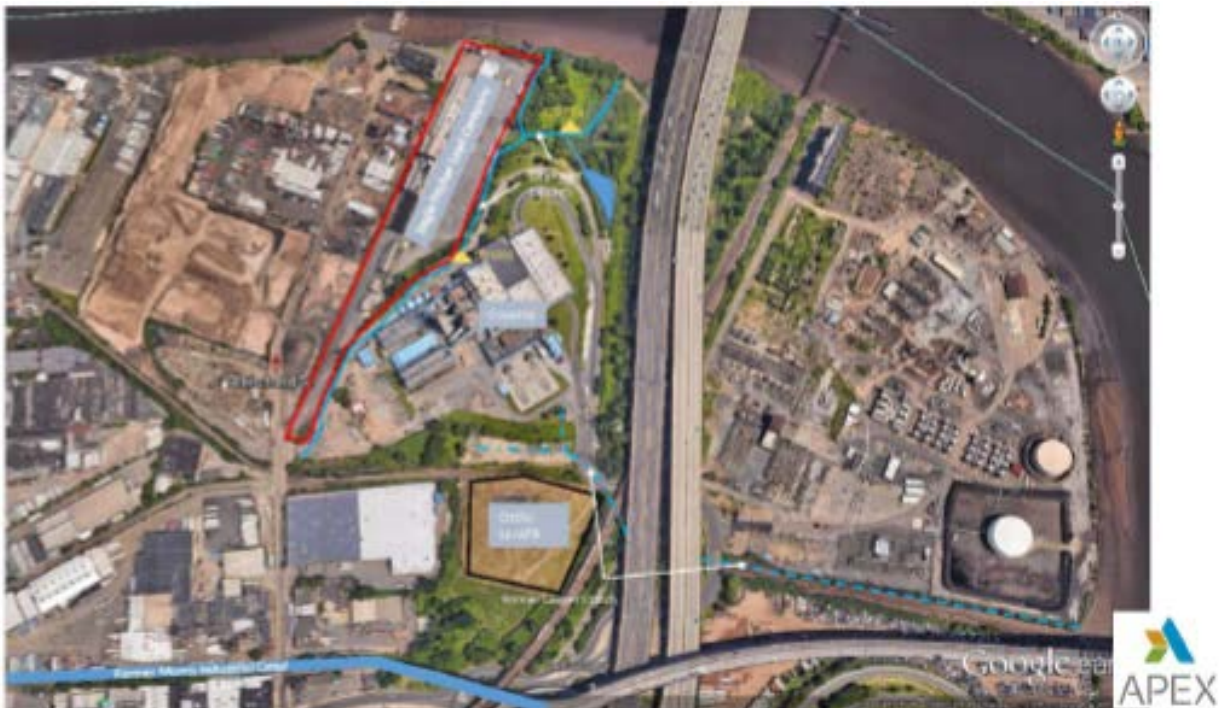
A figure depicting the location of the site relative to surrounding properties and site drainage features is provided below (PAS-00049026):

The letter prepared by Apex Companies, LLC for legal counsel for Covanta, dated January 20, 2017, also notes that lead has been found on the adjacent Ottilio Landfill property which is upgradient from the site (PAS-00048509). In addition, according to a letter prepared by legal counsel for Covanta, dated August 26, 2016, the stormwater ditches on the property are "known to be affected" by drainage from upgradient sources contaminated with lead, including the Ottilio landfill (PAS-00049006).

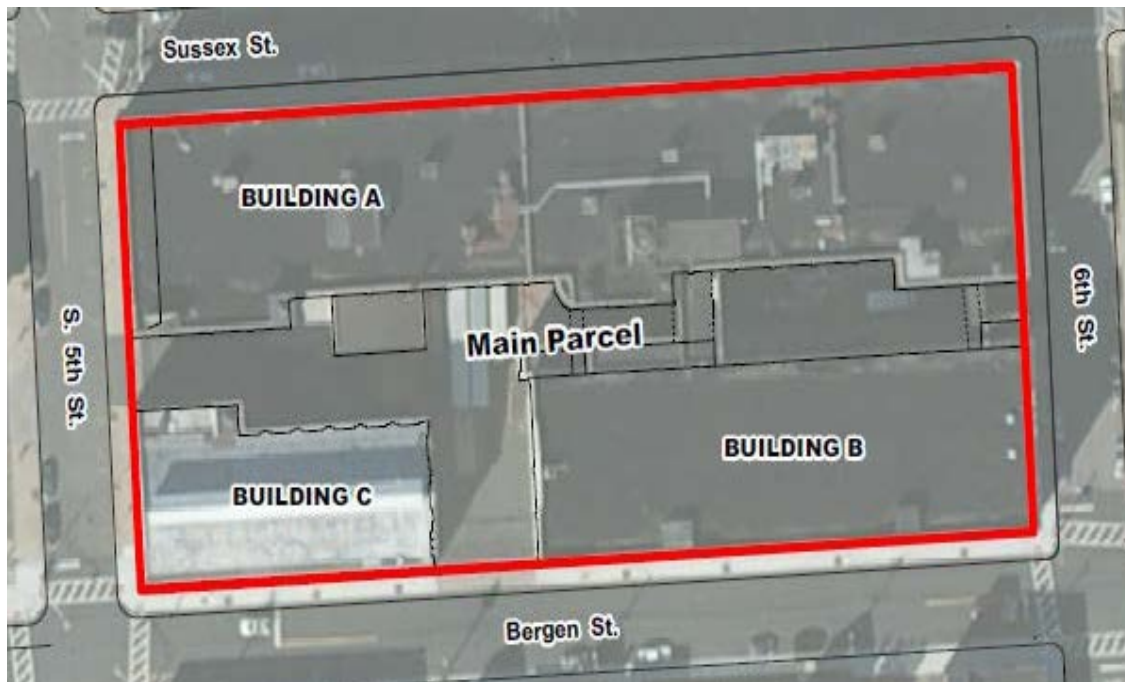
A figure of the 5th Street Facility buildings from the 2015 RAWP is presented below (PAP-00074296):

According to the 2019 Building Assessment, Building A was also known as Building No. 36/37, Building B was also known as Building No. 33, and Building C was also known as Building No. 34 (PAP-00342921). A *RCA Plant Facilities Survey*, dated December 31, 1975, documented the total areas of the buildings as follows: Building A was a three story slab on grade building with an interior area of approximately 109,500 square feet. Building B was a three story slab on grade building with an interior area of approximately 60,700 square feet. Building C had a basement and two floors, with an interior area of approximately 30,700 square feet (PAP-00341704-07). The 2019 Building Assessment and the 1975 Plant Facilities Survey stated Building A was constructed in 1913 and 1914, Building B was constructed in 1907, and Building C was constructed in 1902 (PAP-00341705, 07; PAP-00342921).

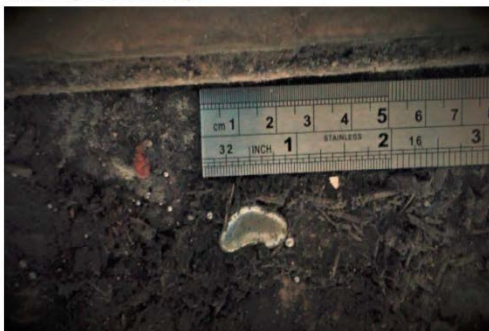
Photographs of visible mercury observed at Buildings B and C are presented below (PAP-00342946 and 54):

Visible Mercury; Third Floor Building B

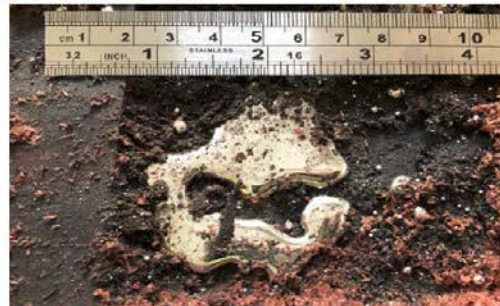
Visible Mercury; Second Floor Building C

Note:
Mercury observed on tar paper layer, between two layers of wood flooring.

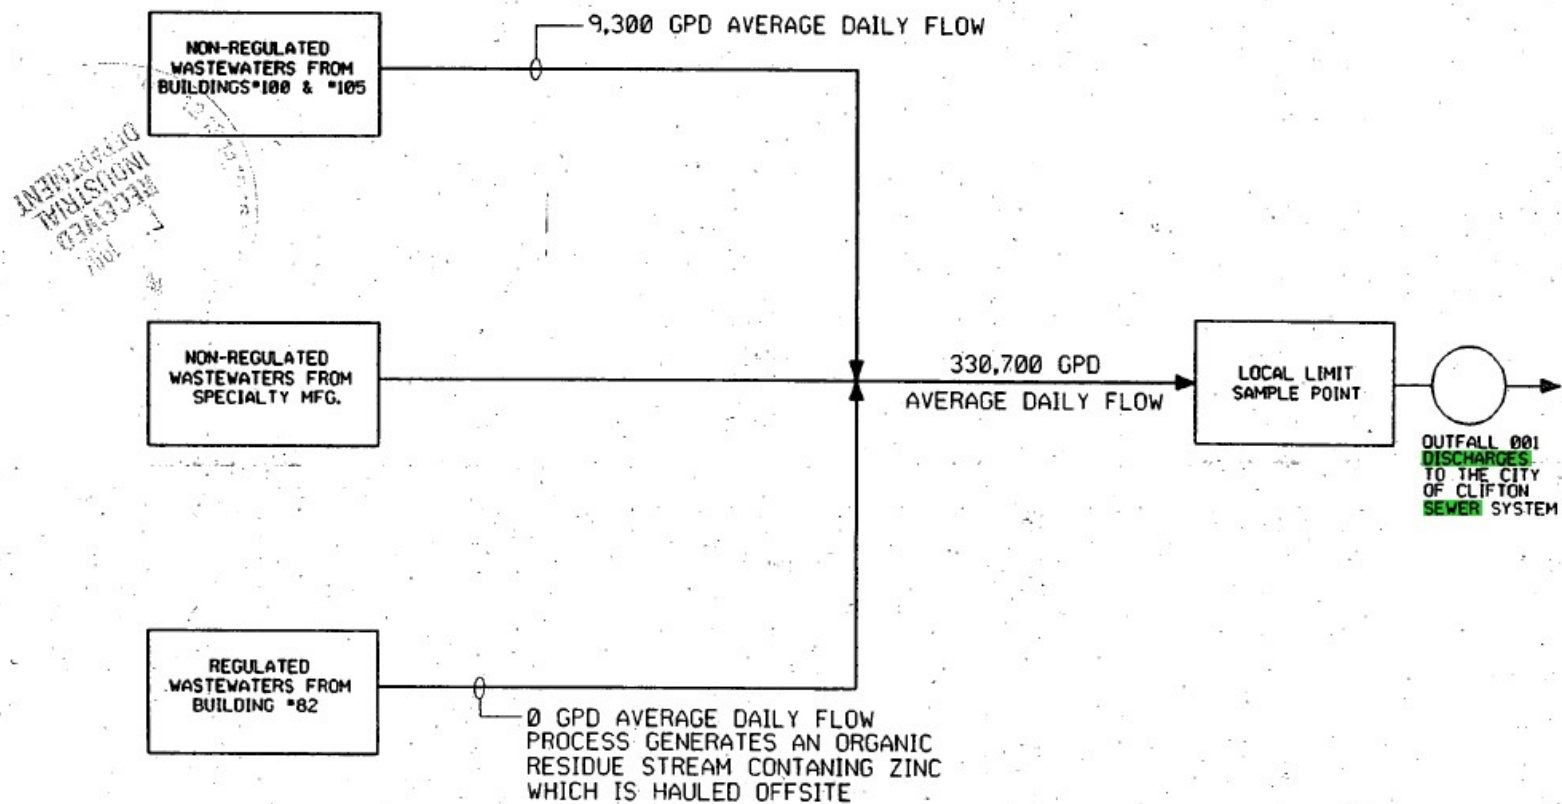
UPDATED
FLOW DIAGRAM
OUTFALL 001
DECEMBER 1994

Appendix B-4. Wastewater flow diagrams for 1993, 1994, and 1995 (PAS-00036328, PAS-00036516-18, PAS-00036534).

OUTLET #1

OUTLET 03401021 FOR USER CHARGE AND PRETREATMENT
SAMPLE POINT/IS LOCATED BY SAMPLE SHED BUILDING *11
LOCATED IN SOUTHWEST CORNER OF PROPERTY
(40 CFR 414)

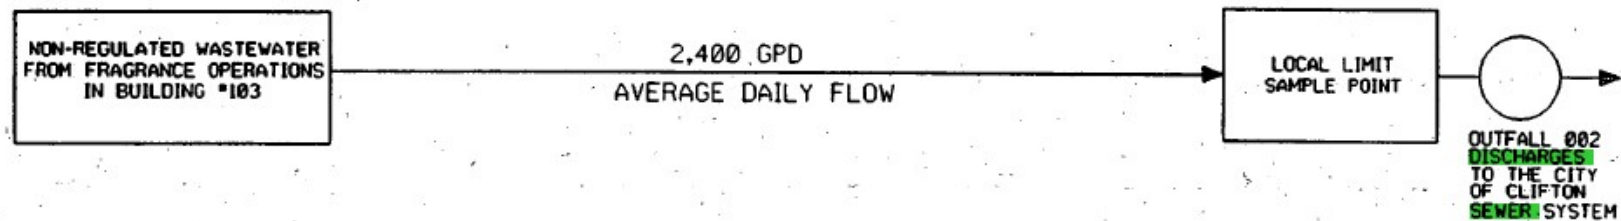
UPDATED
FLOW DIAGRAM
OUTFALL 002
DECEMBER 1994

OUTLET #2

OUTLET 03401022 FOR USER CHARGE AND PRETREATMENT
SAMPLE POINT/IS LOCATED IN THE LOCKER ROOM
IN BUILDING #103
